Case Study

The Stockton mine returns to indigenous tussock and shrubland.

Stockton Mine: Returning Stockton to nature

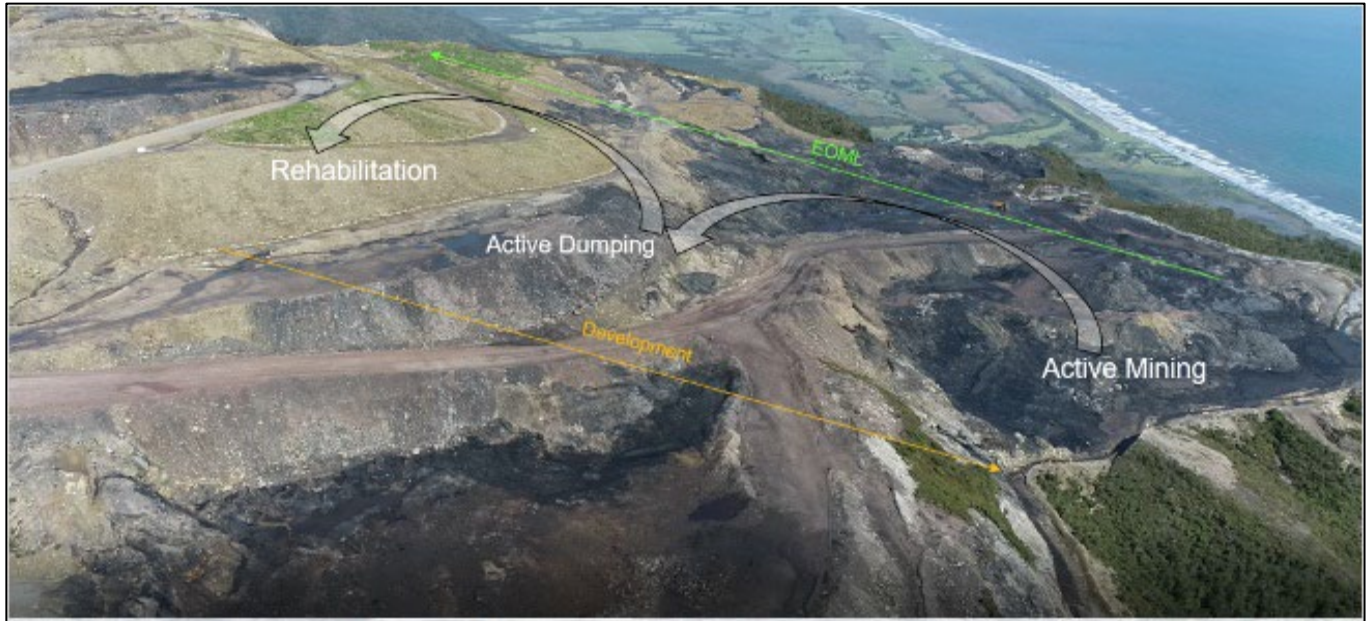
Stockton mine rehabilitation sequence.

Stage 1: Shape slopes

Overburden dumps start out at slopes of 37 degrees separated by 8-11 metre-wide drainage benches. A dozer operator then recontours these earthworks into smooth slopes of 18-20 degrees. Compaction of material reduces pore space between substrate particles, reducing the presence of oxygen, and slowing the production of AMD.

Stage 2: Cap surface and lay growth medium

Next comes a 400mm-thick layer of weathered granite to seal the substrate, which is then compacted, further reducing the rate of acid-forming reactions. This is key to freshwater management on site.

Dozer and excavator operators then lay a 200mm thickness of growth medium on top of the compacted granite, in a 1:4 to 1:10 ratio of biosolids to soil. The ratio varies, depending on the age and quality of soil from stockpiles of overburden from other mined areas. Biosolids add nutrients to naturally poor-quality soils on the Stockton plateau to boost seedling growth. It is critical to get the mix right because too much biosolids produces too much exotic grass growth, stymying later growth of native vegetation.

Stage 3: Hydro seed grass, and plant seedlings

Hydroseeding is done with a mix of seeds, water, glue and paper to create a pulp sprayed onto the growth medium layer. This stabilises the rehabilitation surface and prevents erosion. The work is carried out early in the rehabilitation process, and the grass grows quickly for large-scale cover.

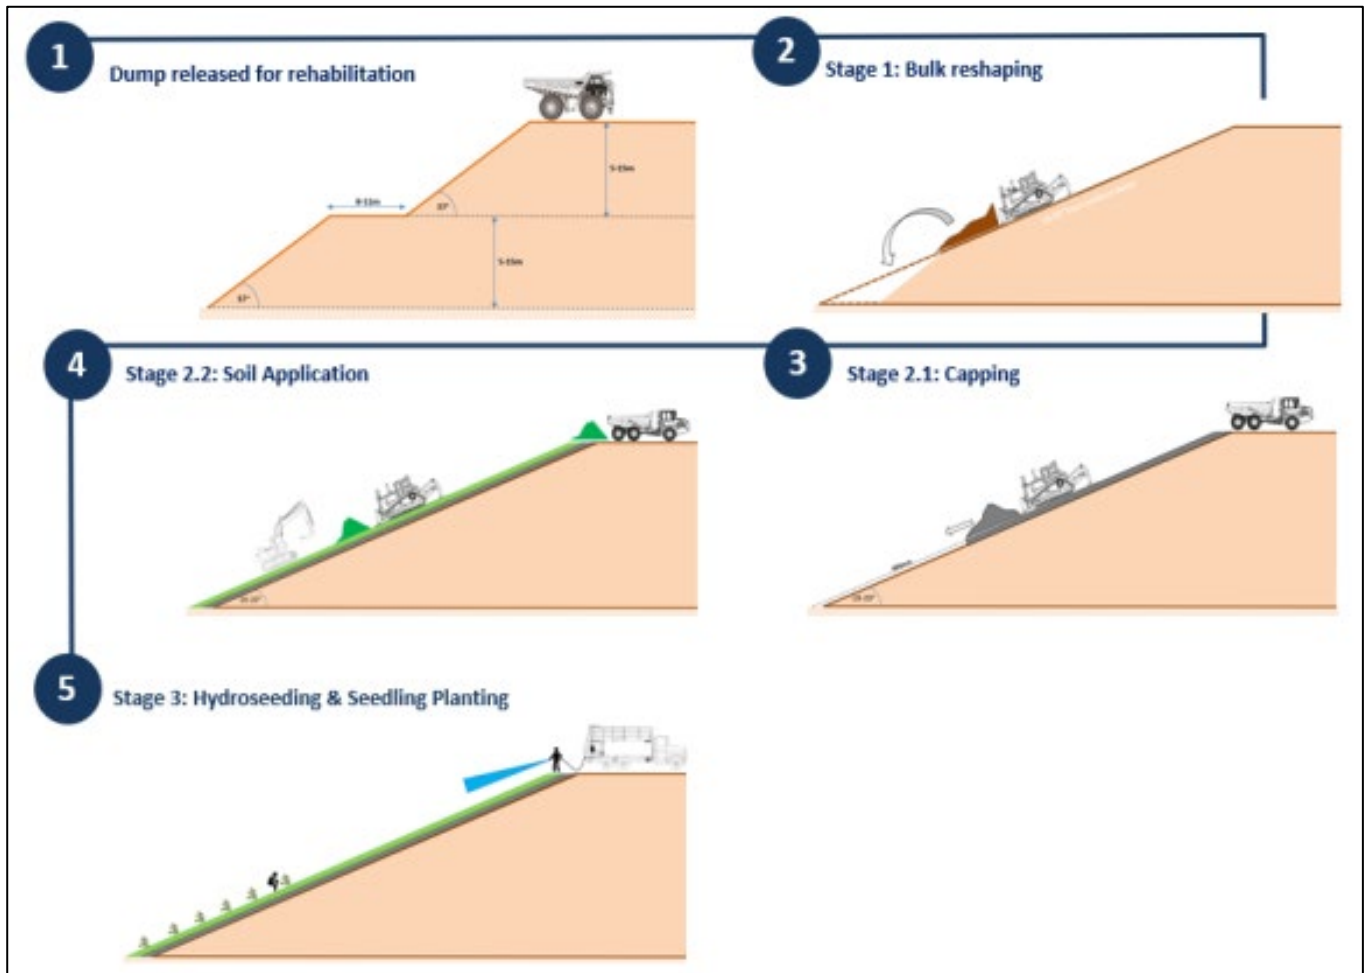
Flow chart of the current process for rehabilitation at Stockton.

A challenge at Stockton has been to achieve large-scale and fast growing ground cover after recontouring mined areas to manage erosion and acid mine drainages (AMD). The breakthrough came more than a decade ago on mixing processed biosolids from Christchurch City Council and stockpiled soil from overburden stripping at the mine. This creates a durable and fertile growth medium to support plantings, as well as improving soil pH (reducing acidity).

Hydroseeding of exotic grass species on this enhanced growth medium produces fast growth, stabilising ground and reducing erosion, and preparing it for planting with indigenous species. The grass eventually dies off, as areas return to 100% indigenous plant cover. Contractors have planted more than 400ha in this way to date, or 36% of the site, with a further 700ha of rehabilitation ahead.

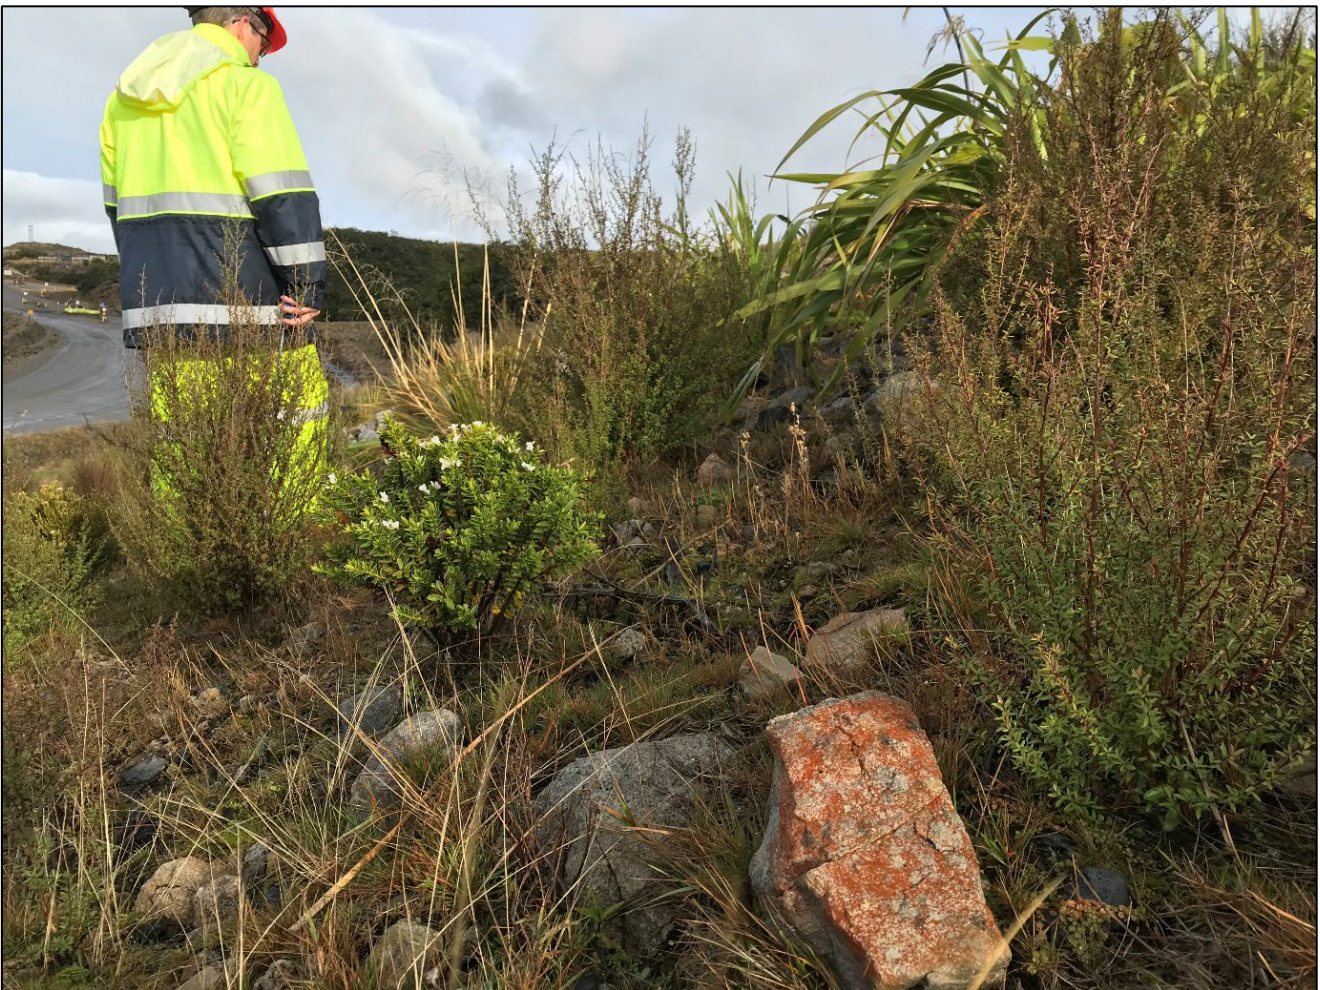
Mix of native seedlings on a typical rehabilitation slope at Stockton.

Bathurst then stages the planting of eco-sourced grasses, trees and shrubs – 25 species in all – so that the natives can take over from the exotic grass cover. Species include rata, beech species, mānuka, flax (harakeke), hebes, astelias, broadleaf, tussock, coprosmas and toetoe. This mix will depend from place to place on altitude, exposure to wind, and sun position.

Plantings have stepped up over time from 6500 seedlings a hectare to 9000ha, for better ground cover. One contractor can plant upwards of 800 plants a day, depending on weather and terrain.

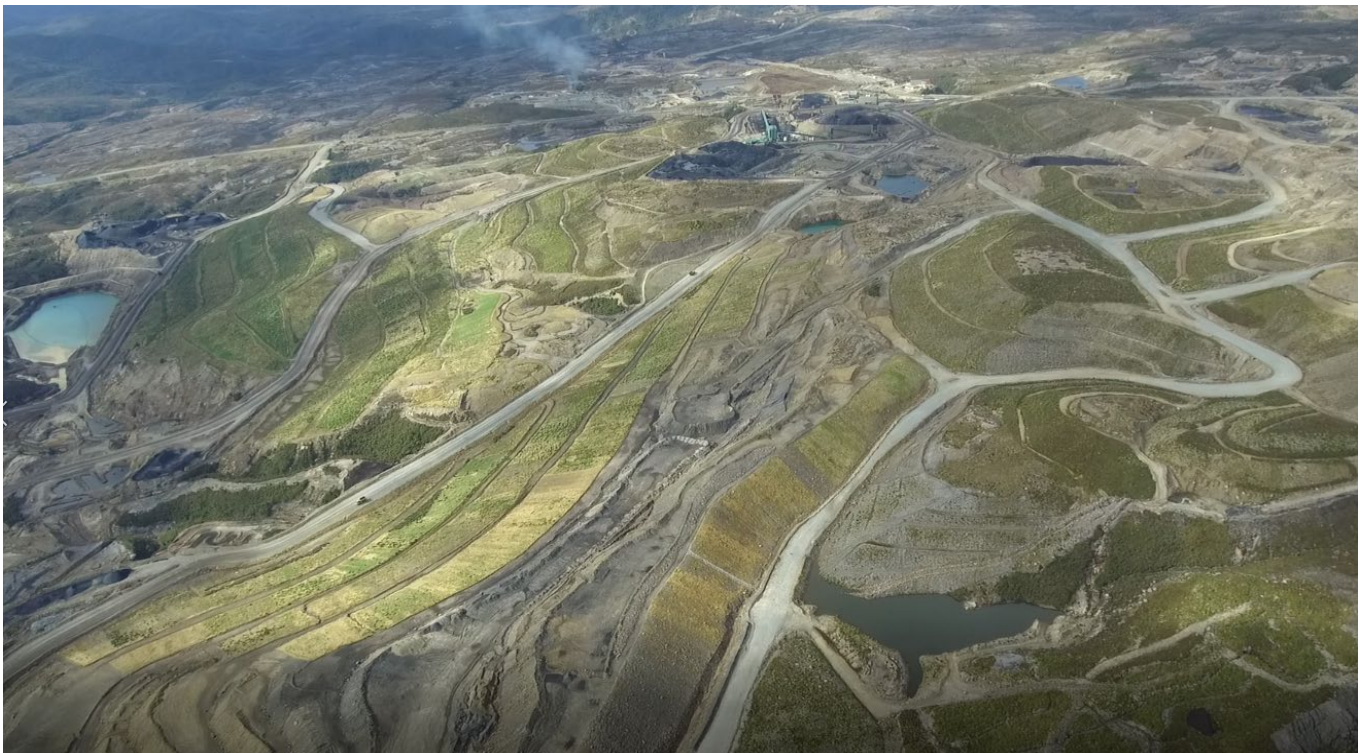
Aerial view of Stockton coal mine site rehabilitation - c400 ha to date.
